Sika at Work

Waterproofing Solution for Thornbridge Car Park, Lincoln, U.K.

Waterproofing: **Sikalastic®**

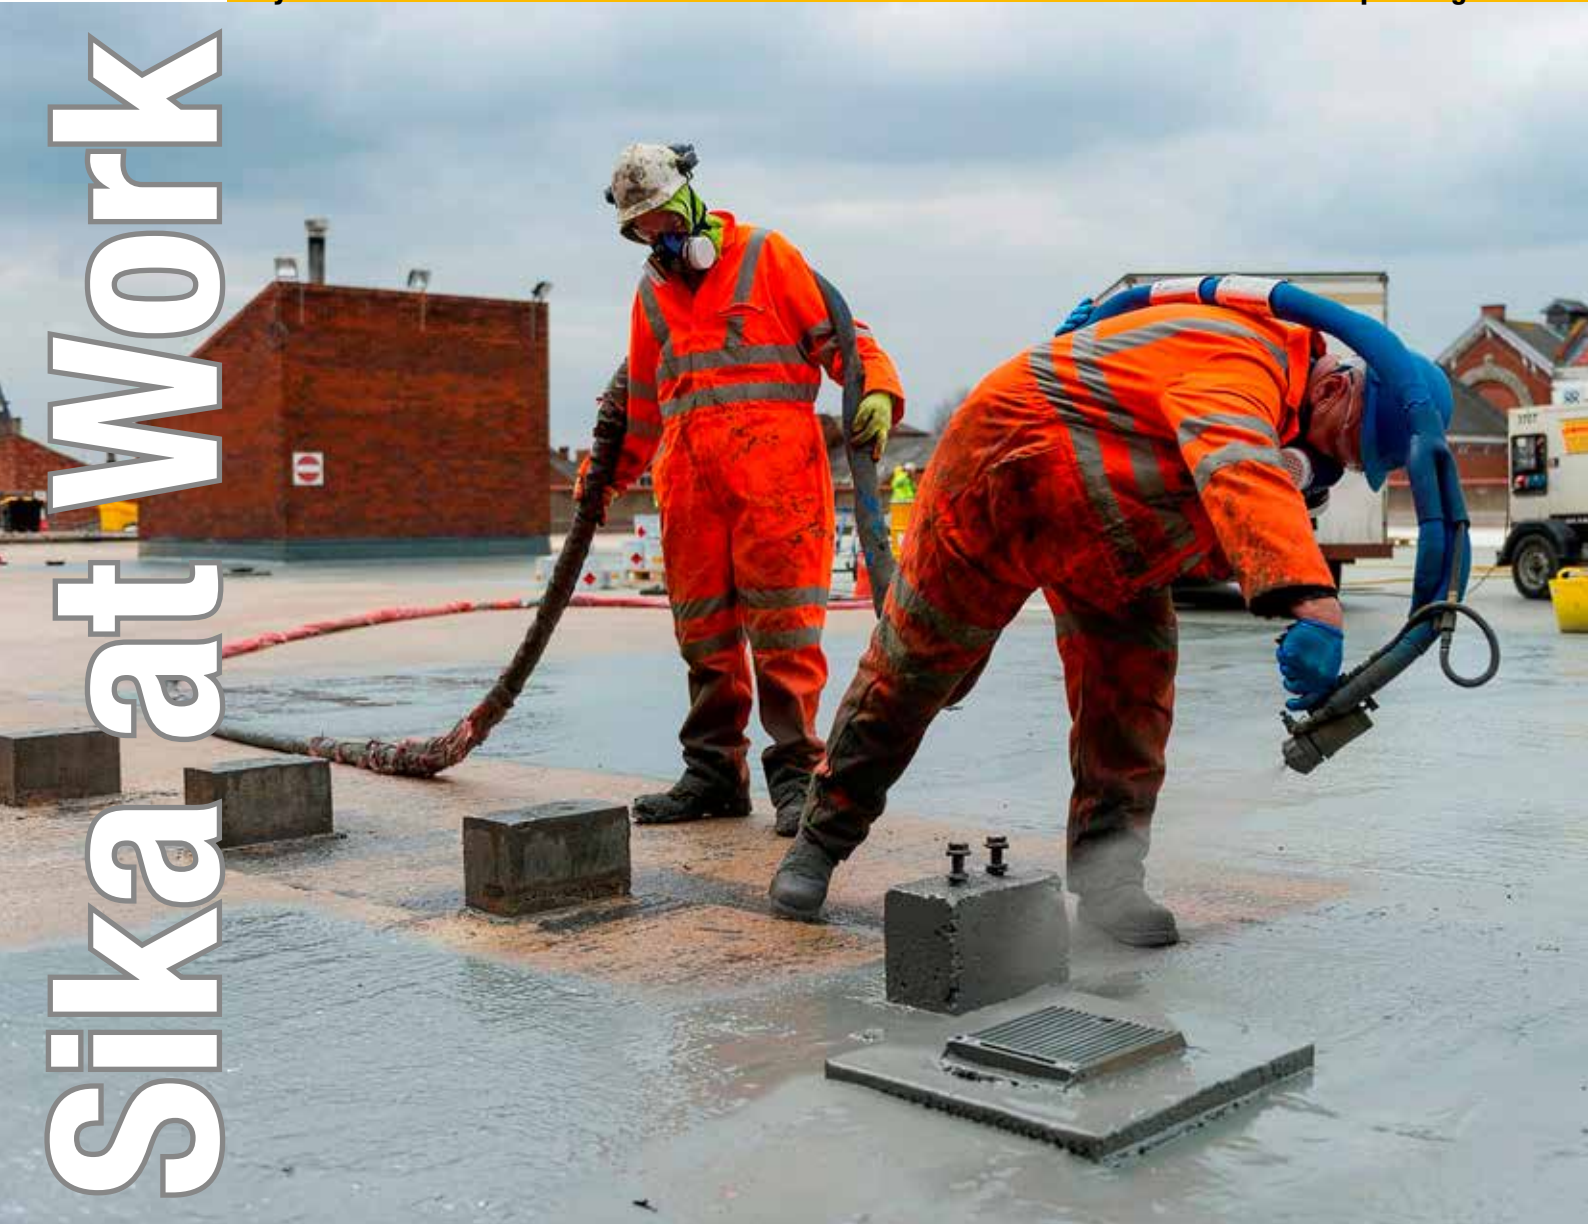
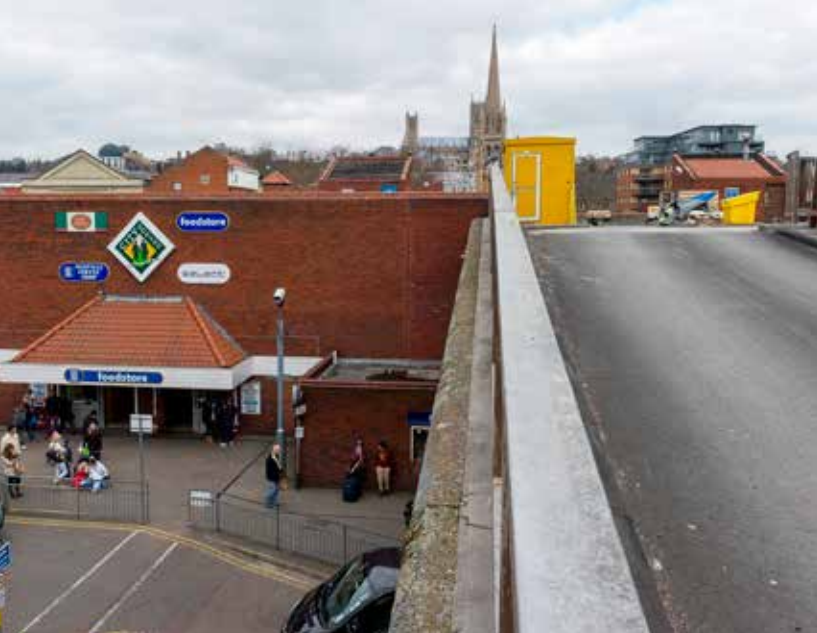
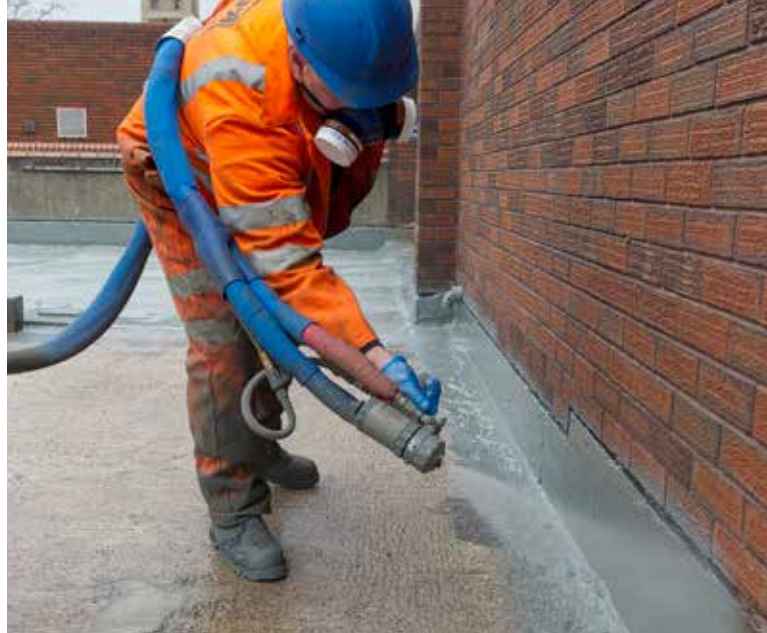
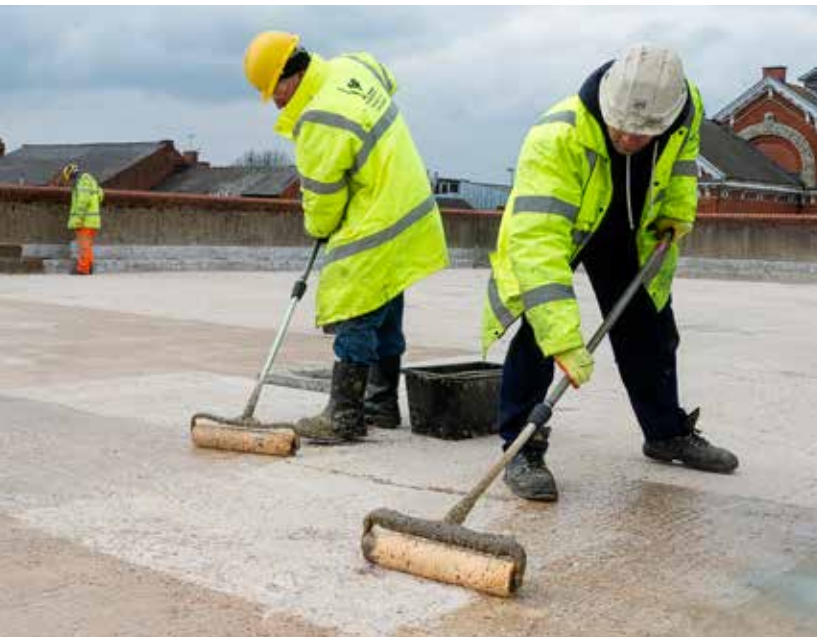
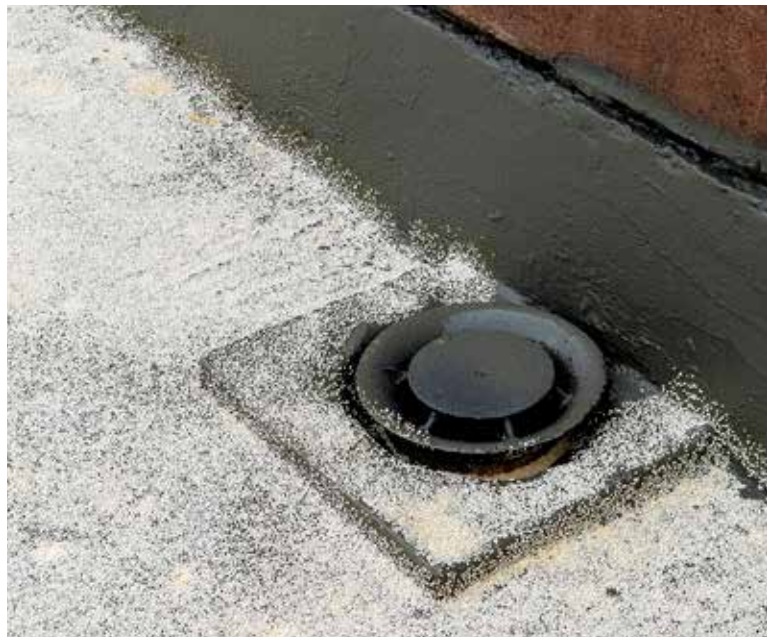
3500 m² of Suspended Car Park. The Car Park had an asphalt deck that was failing badly, there was no waterproofing membrane under the asphalt, in addition, the asphalt itself was not elastic. With shops below the car park this situation caused costly damage to the stock.

The top-deck carpark shall be repaired and waterproofed. So old asphalt was taken away, a new fast curing elastic membrane should be applied directly under the new applied asphalt.

Due to the advantages of the fast curing **Sikalastic**[®] primer and membrane, the application work could be proceeded in winter. Furthermore, **Sikalastic**[®]-841 ST has good elastic and crack bridging properties which meet the requirements.

This **Sikalastic**[®] system is fully bonded to the substrate and the asphalt. **Sikalastic**[®]-841 is very fast curing and asphalt can be applied immediately following this layer of coating.
